CONFERENCE ON THE
ECOLOGICAL ASPECTS OF
INTERNATIONAL DEVELOPMENT
AIRLIE HOUSE, WARRENTON, VA. DEC. 9-11, 1968

THE ANCHICAYA HYDRO PROJECT IN COLOMBIA
DESIGN, CONSTRUCTION AND SEDIMENTATION PROBLEMS

Robert N. Allen

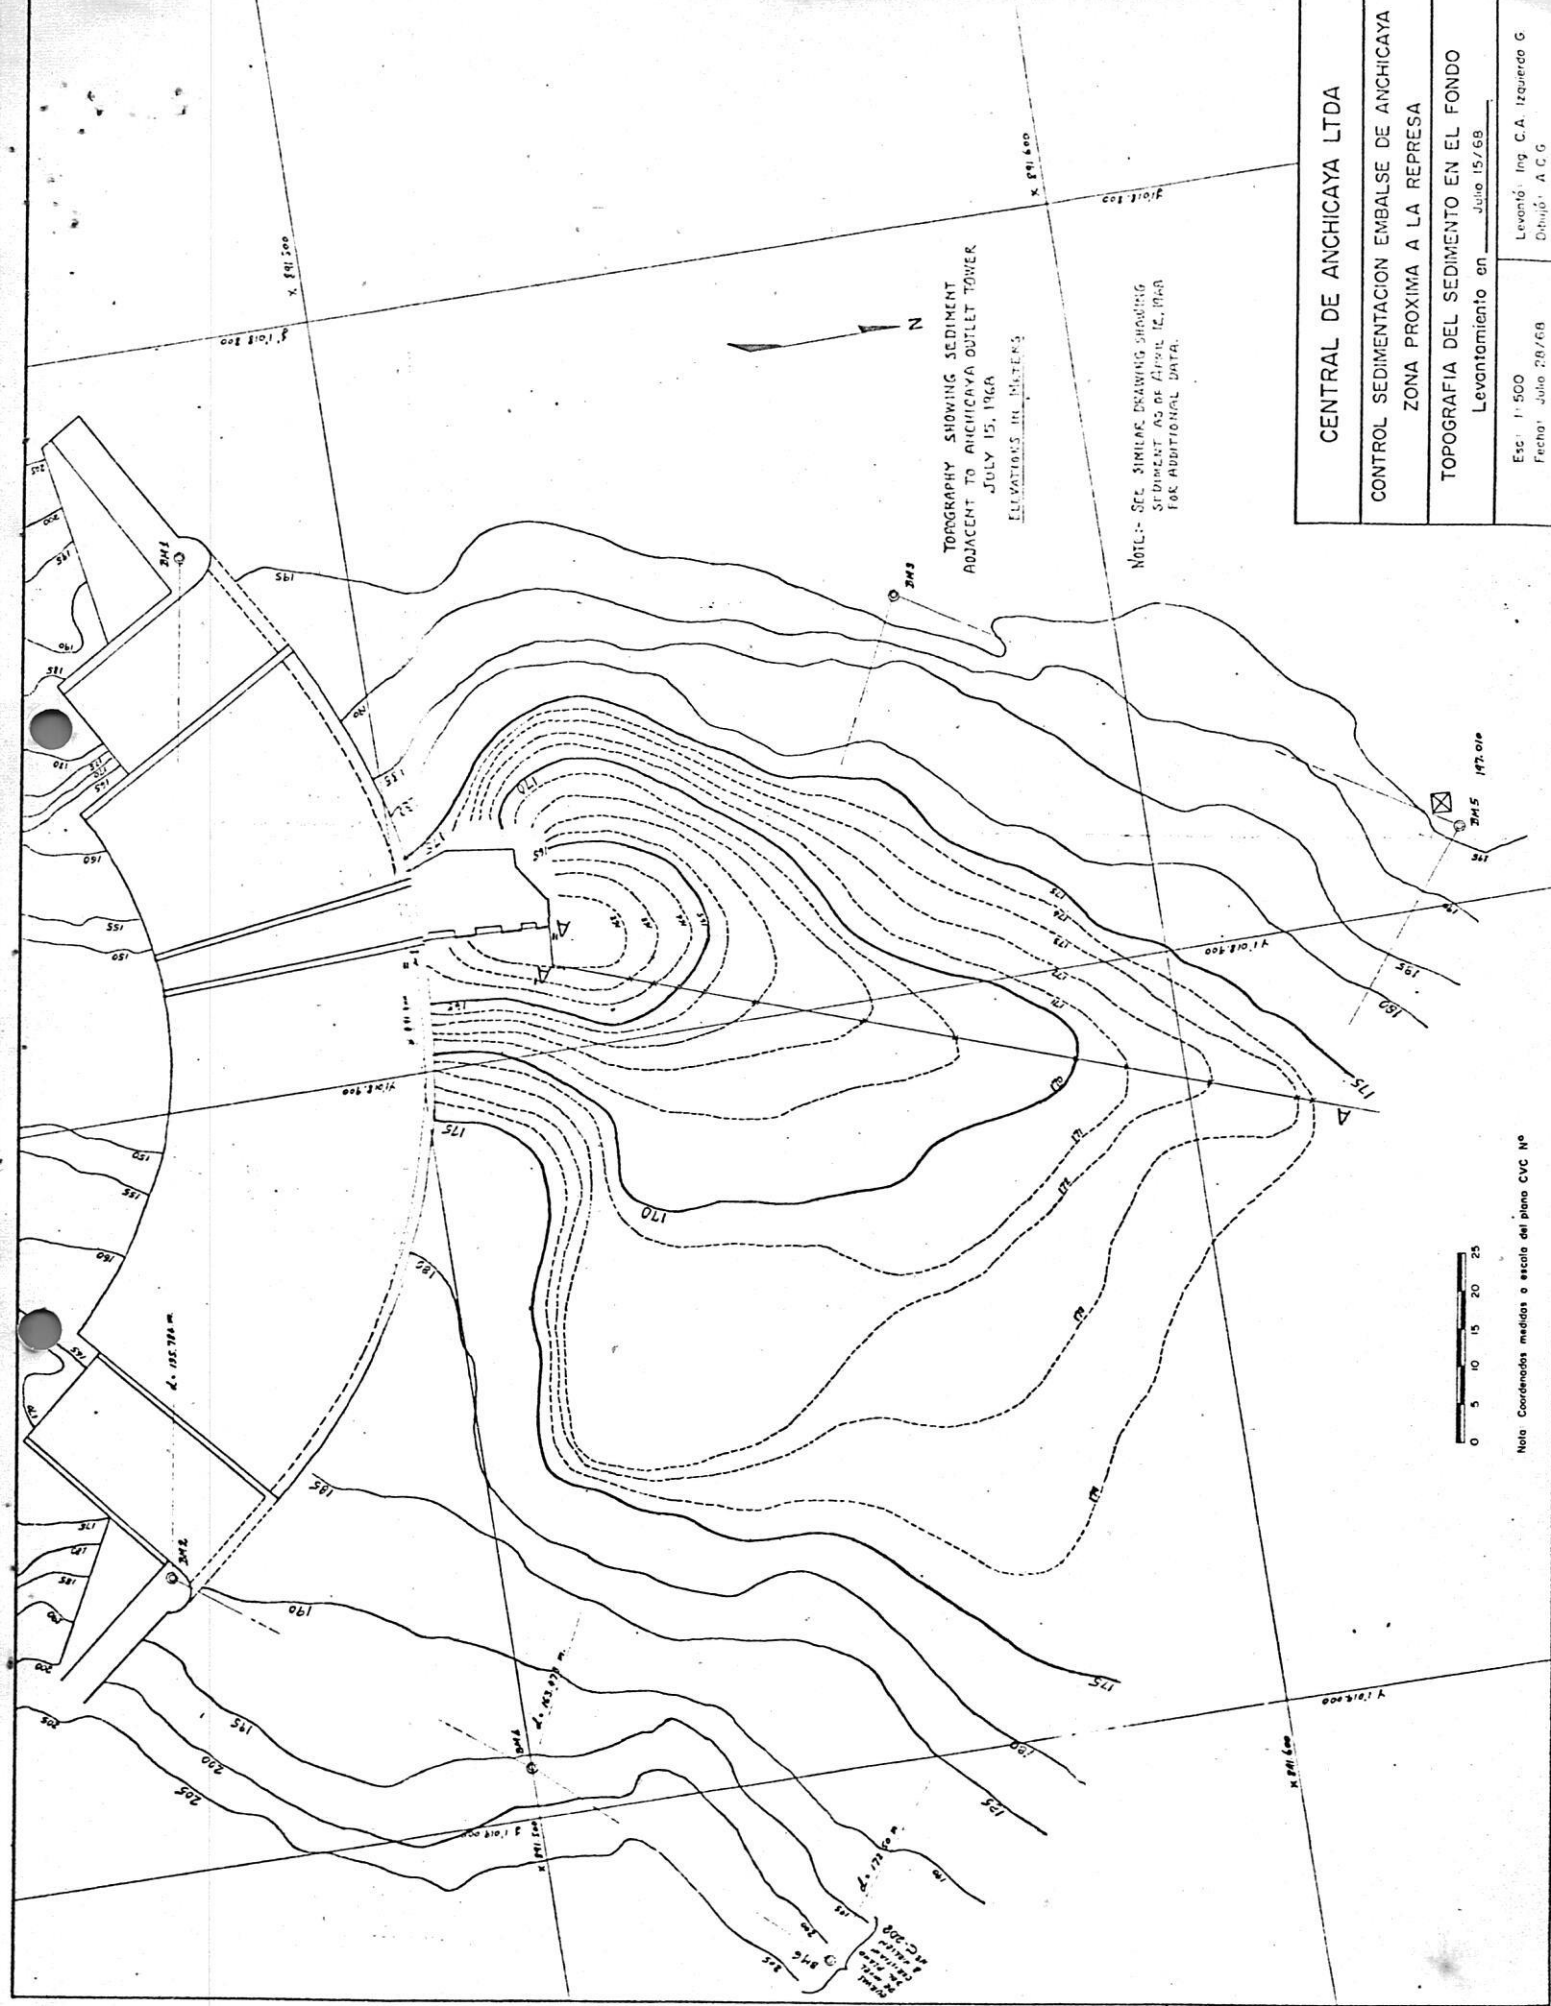
TOPOGRAPHY SHOWING SEDIMENT
ADJACENT TO ANCHICAYA OUTLET TOWER
JULY 15, 1968
ELEVATIONS IN METERS

A drawing attached shows the successive sediment profiles and quantity tables obtained from sounding records taken since closure in April 1955, with additions of the latest information relative thereto. Other maps greatly reduced show the entire reservoir with sounding section locations. Larger scale maps of the downstream end of the reservoir show the dredge operating area, the shore anchor locations, and the method of attaching the dredge thereto. Other drawings show typical progressive sediment cross sections for two sounding sections. Maps and profiles show conditions adjacent to the outlet tower. Various other maps and tables are also included.
